# Inspection Report

**Property Address:**  
SAMPLE ST  
TACOMA WA

**Eagle Home Inspections**

<b>Date:</b> 10/13/2025	<b>Time:</b> 10:00 AM	<b>Report ID:</b> SAMPLE 2025
<b>Property:</b> SAMPLE ST TACOMA WA	<b>Customer:</b> SAMPLE REPORT	<b>Real Estate Professional:</b>

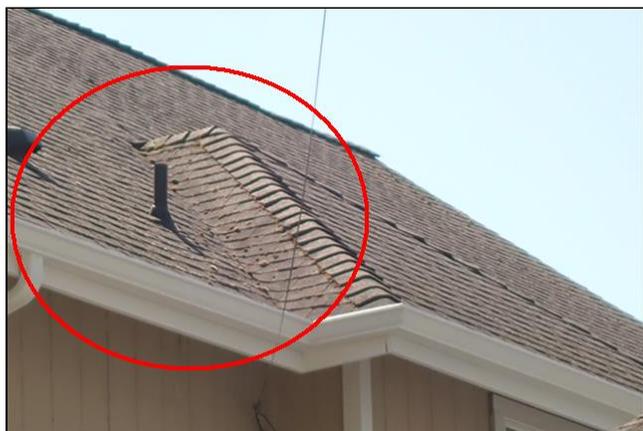
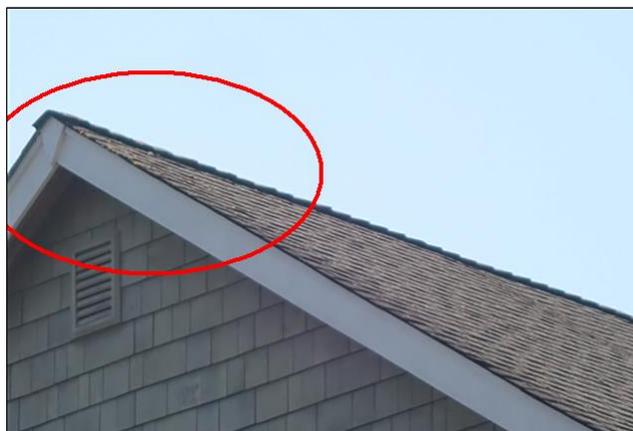
1.0 Item 1(Picture)

🏠 1.0 (1) THERE IS MOSS GROWTH ON AREAS OF THE ROOF. THIS IS A MAINTENANCE ITEM AND CAN REDUCE THE USEFUL LIFE OF THE ROOF. I RECOMMEND FUNGICIDE TREATMENT AND REMOVE MOSS AS NEEDED. DO NOT POWER WASH THE ROOF. HAVE A QUALIFIED PERSON DO THE WORK..

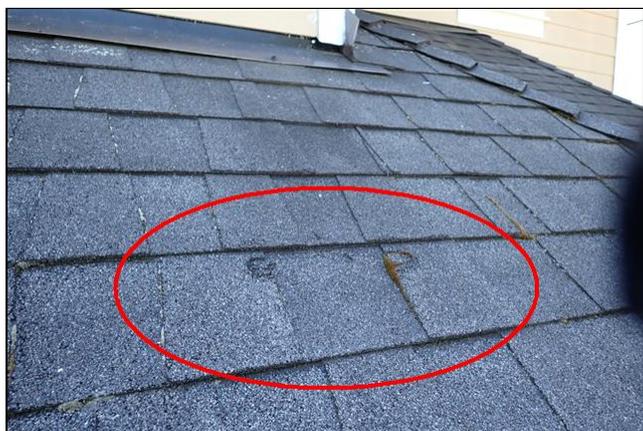
1.0 Item 3(Picture)

🏠 (2) SPOT IMPACT DAMAGED SHINGLE AT THE LOWER FRONT ROOF. ROOF IS IN ITS LAST THIRD OF LIFE DESIGN. WITH SOME REPAIR AND CLEANING/MAINTAINED, THE ROOF WILL LAST THROUGH DESIGN OF 30 YEARS.

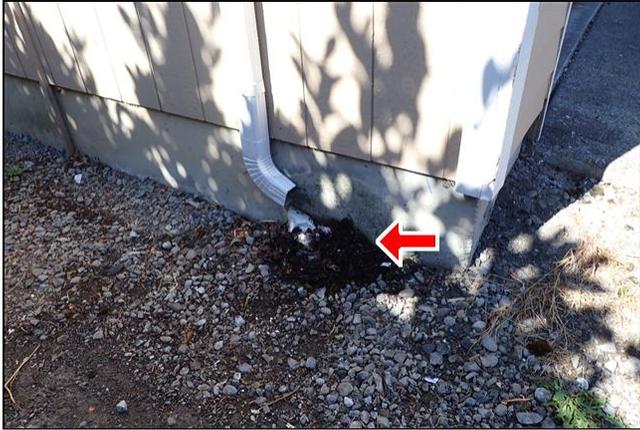
1.4 Item 1(Picture)

**1.4** DOWNSPOUT DAMAGED AND IS DISCONNECTED FROM IN GROUND DRAIN. RECOMMEND FURTHER EVALUATION/REPAIR. CONDITION OF IN GROUND IS NOT DETERMINED.

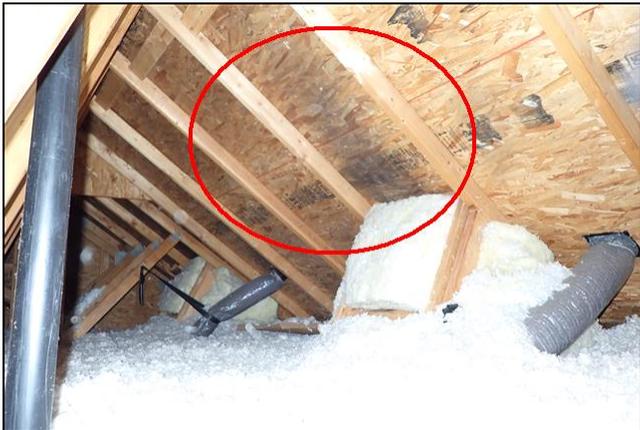
1.5 Item 1(Picture)

**1.5** The OSB ROOF sheathing AT AREAS IS DISCOLORED IN THE ATTIC. THIS APPEARS TO BE LOCALIZED AT VENT TERMINAL AND NEXT TO SKY LIGHT. RECOMMEND FURTHER EVALUATION/INCREASE VENTING.

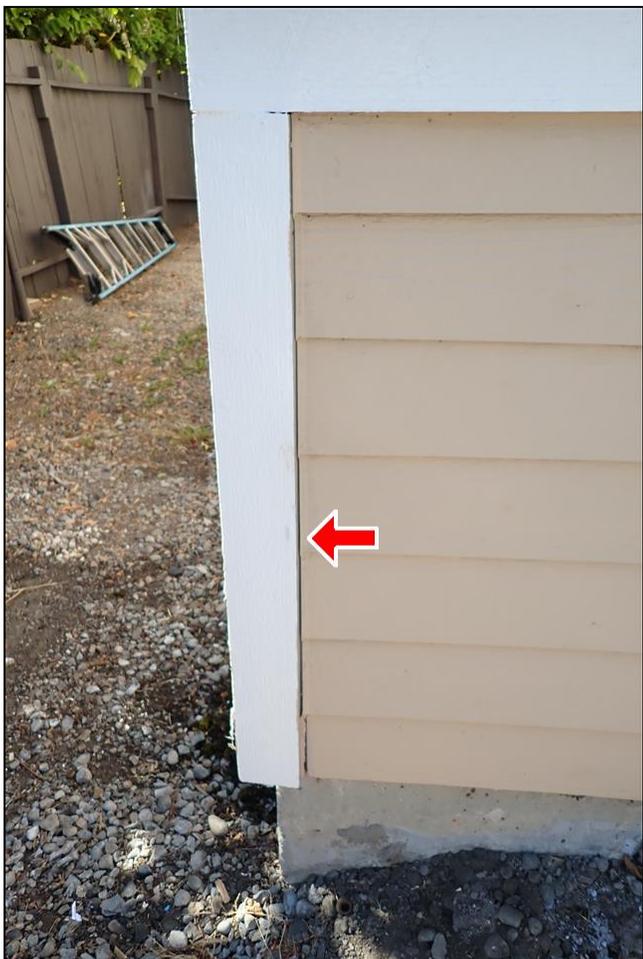
2.0 Item 1(Picture)

**2.0 (1) FAILING CAULK AT AREAS OF THE EXTERIOR SIDING. THIS IS A MAINTENANCE ITEM. CAULK AND PAINT IS THE EXTERIOR'S PROTECTIVE SHELL. RECOMMEND CAULK/REPAIR AS NEEDED.**

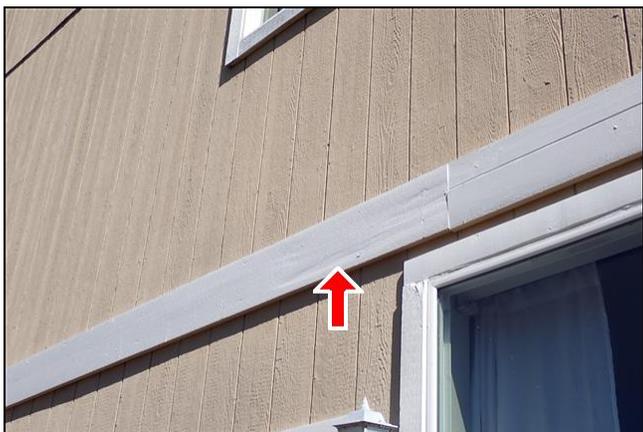
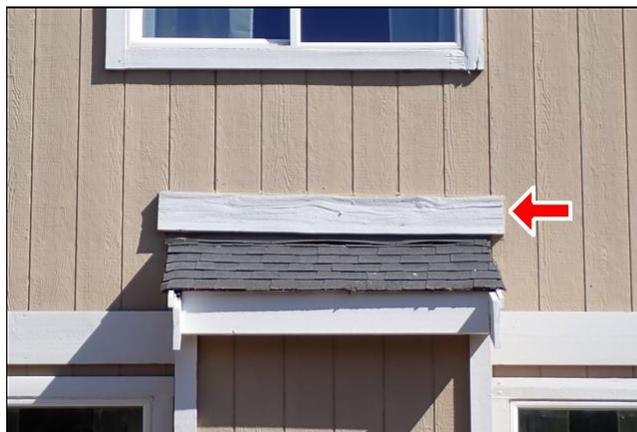
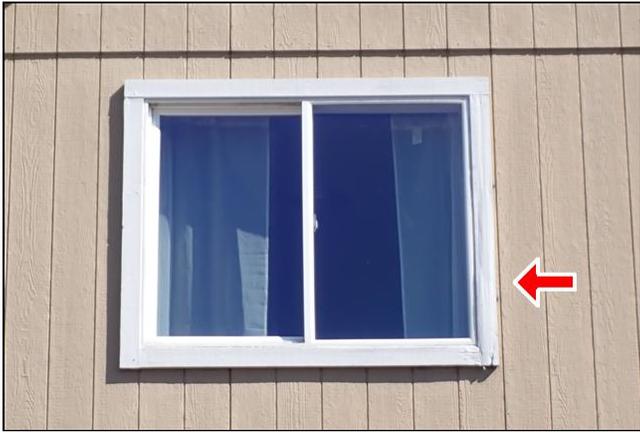
2.0 Item 2(Picture)

**(2) TRIM at the exterior AT BACK WINDOWS AND BELLY BOARD HAS FUNGI/ROT DAMAGE. Further deterioration WILL occur if not corrected. A qualified LICENSED CONTRACTOR should repair or replace as needed.**

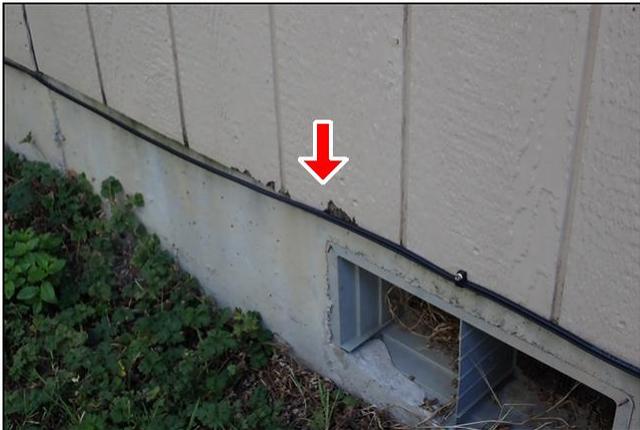
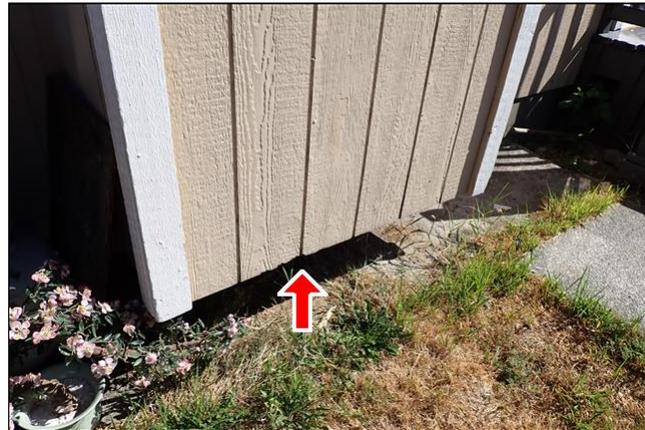
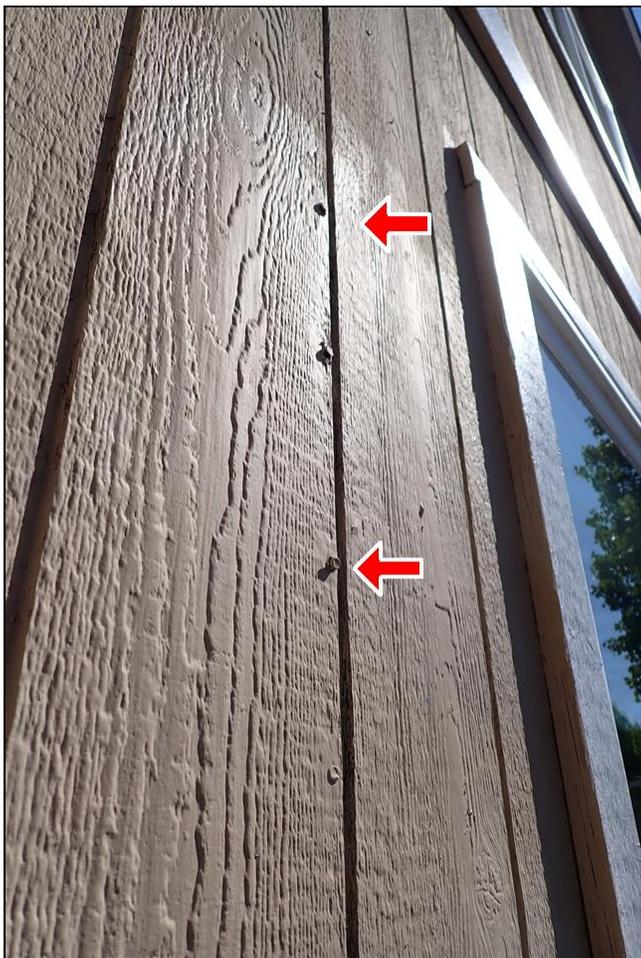
2.0 Item 5(Picture)

🏠 (3) The composite board siding at the exterior in areas is deteriorated along bottom edge Further deterioration WILL occur if not corrected. A qualified person/contractor should repair or replace as needed.

ALSO NOTED SOME RAISED NAIL HEADS THAT THAT NEED TO BE SET AT THE BACK.

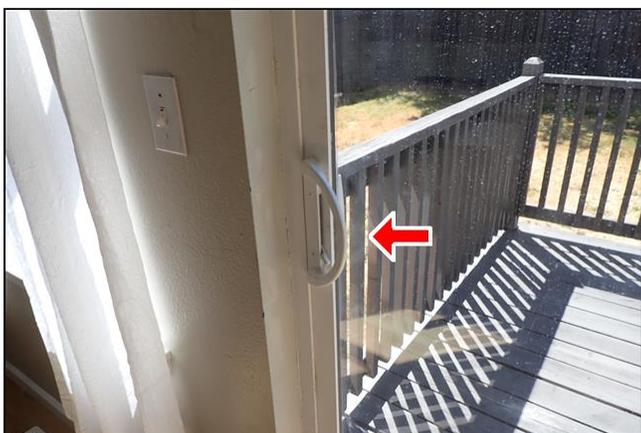
2.1 Item 1(Picture)

**2.1** LATCH FOR BACK SLIDER LOCK SET IS NOT ENGAGING OR WORKING PROPERLY. THIS IS A MAINTENANCE ITEM. RECOMMEND REPAIR BY QUALIFIED PERSON/REPAIRMAN.

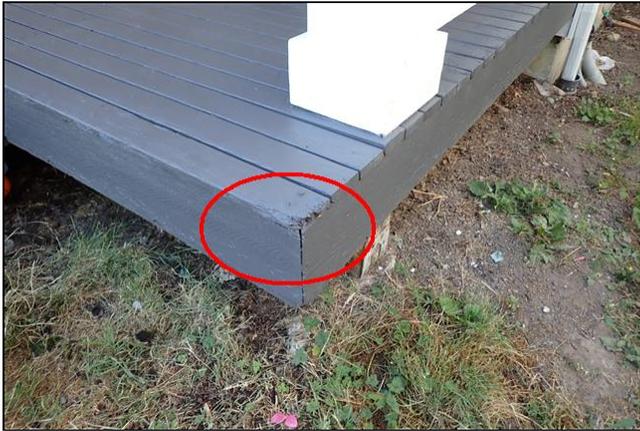
2.3 Item 1(Picture)

2.3 (1) MINOR REMAINS OF FUNGI DAMAGE AT CORNER OF FRONT PORCH YET IS PAINT SEALED. RECOMMEND MAINTAIN.

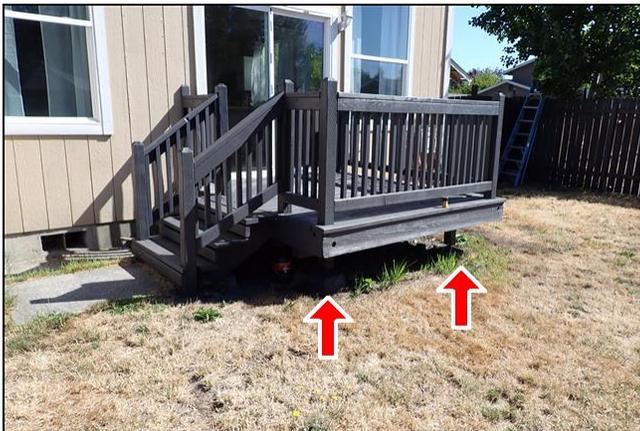
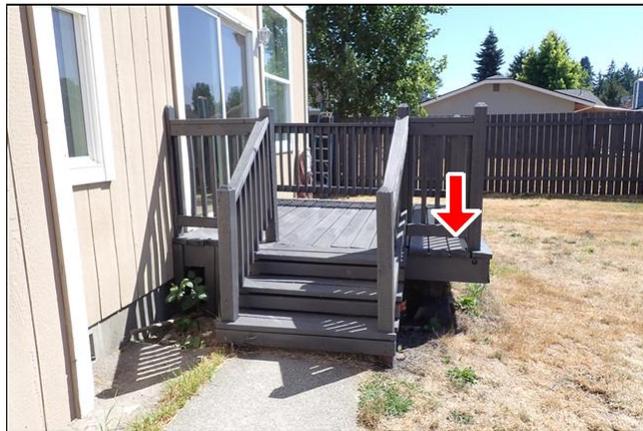
2.3 Item 2(Picture)

(2) THE SUPPORT POSTS FOR THE BACK DECK HAVE SETTLED CAUSING DECK TO BE OUT OF LEVEL. RECOMMEND FURTHER EVALUATION/REPAIR.

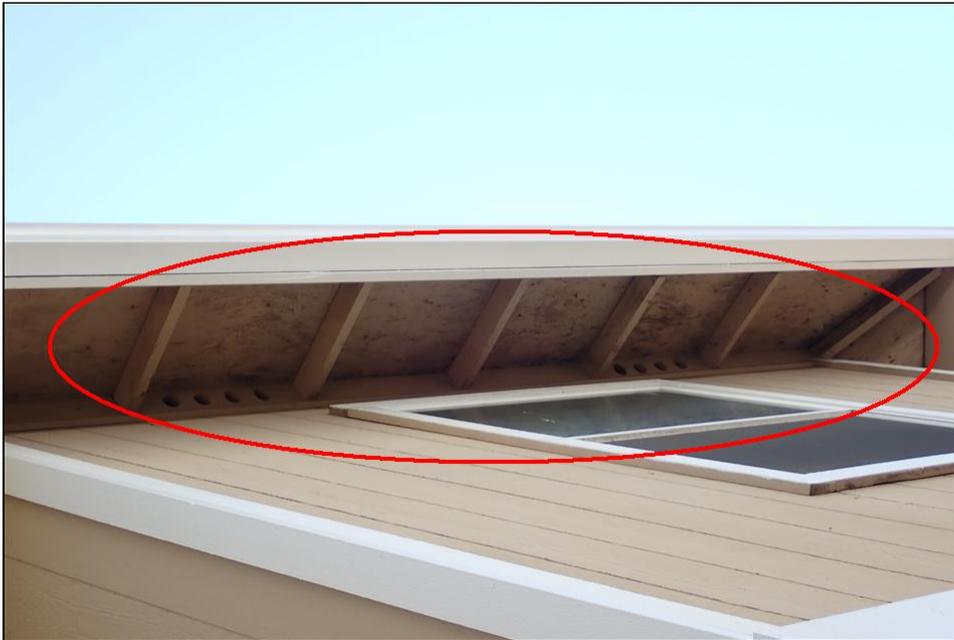
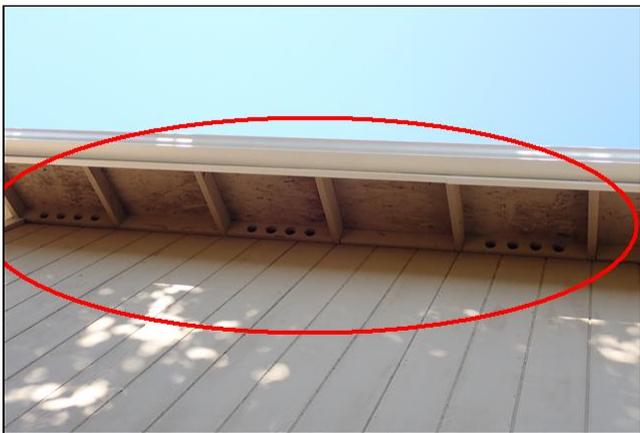
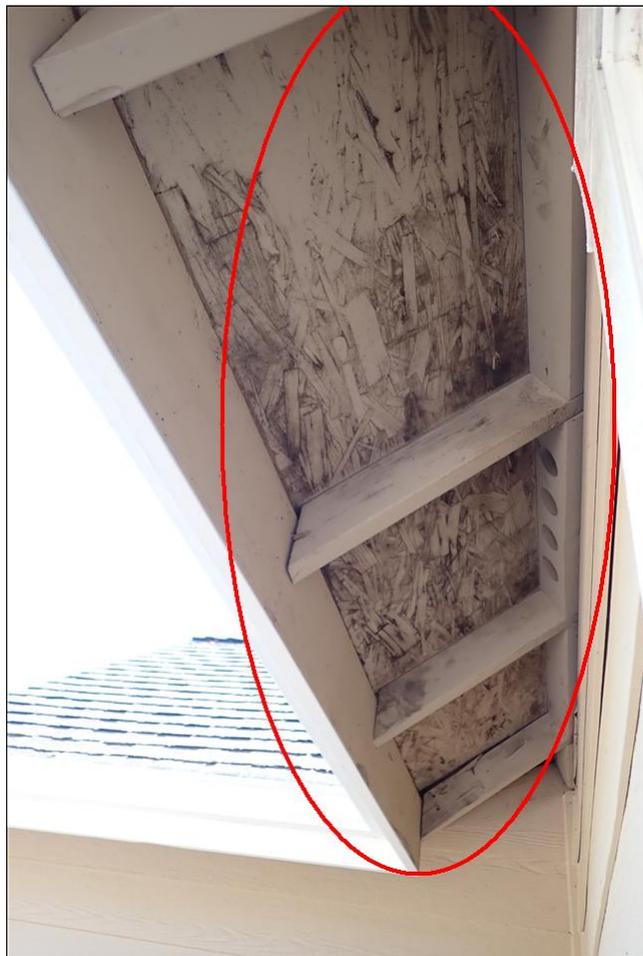
2.5 Item 1(Picture)

🏠 2.5 (1) The paint on SOFFITS is failing WITH INDICATION OF SURFACE FUNGI PRESENT AT AREAS WITH POSSIBLE SPOT ROOF LEAK(S). I recommend prep, TREAT WITH ANTI-MICROBIAL AS NEEDED AND paint at the exterior in areas.

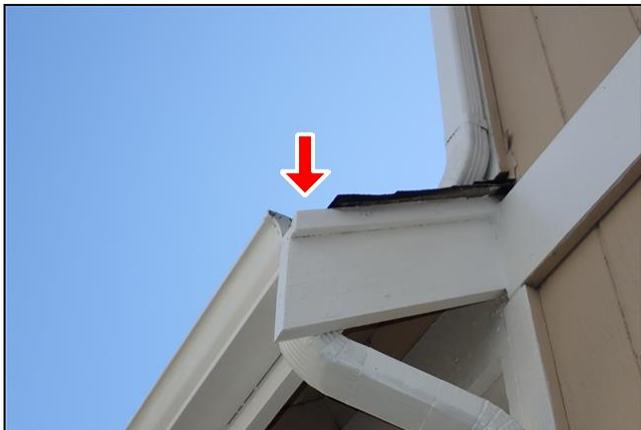
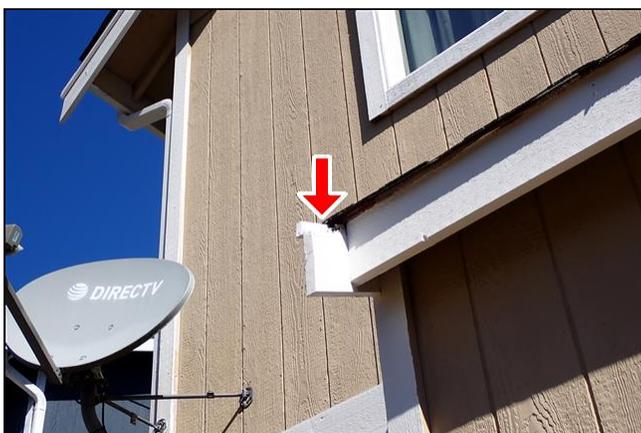
2.5 Item 4(Picture)

🏠 (2) MISSING ROOF TAB/FLASHING AT FASCIA ENDS AT THE LEFT SIDE AND BACK. THIS COULD CAUSE WATER DAMAGE OVER TIME. HAVE A QUALIFIED PERSON CORRECT AS NEEDED.

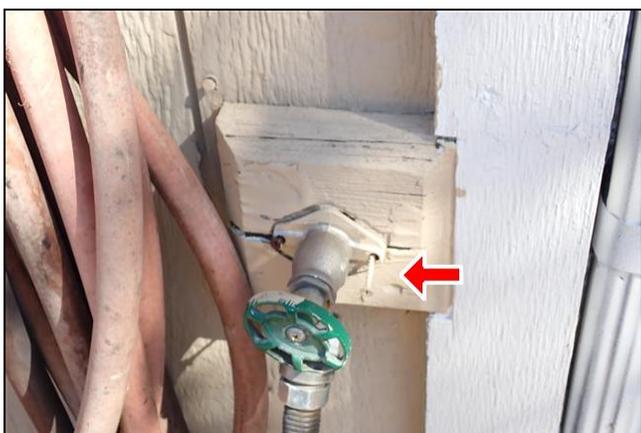
2.6 Item 1(Picture)

🔧 2.6 The hose bib loose and needs securing to wall AT THE BACK. AN UNSECURED HOSE BIB IS PRONE TO DAMAGE IF HOSE IS PULLED TOO HARD. RECOMMEND SECURING WITH SCREWS.

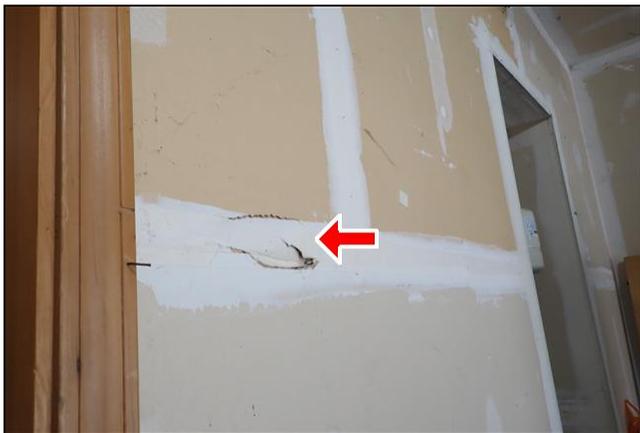
3.2 Item 1(Picture)

**3.2 RECOMMEND REPAIRING ANY SHEETROCK CUT OUTS/DAMAGE IN THE GARAGE TO MAINTAIN FIRE WALL PROTECTION.**

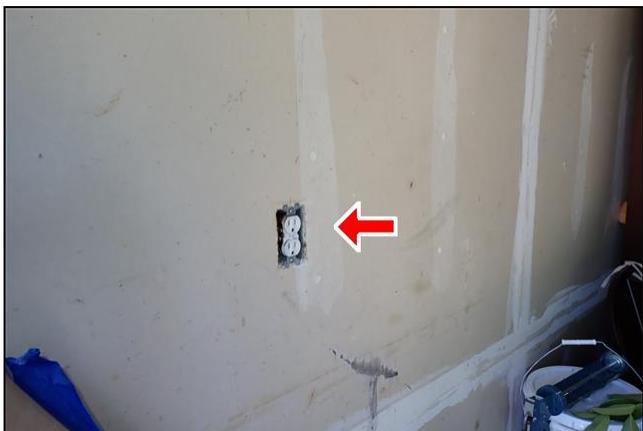
3.7 Item 1(Picture)

**3.7** OUTLET/SWITCH/JUNCTION BOX IS missing cover-plate. Electrical issues are considered a hazard until repaired. RECOMMEND INSTALLING COVER PLATE(S) FOR SAFETY.

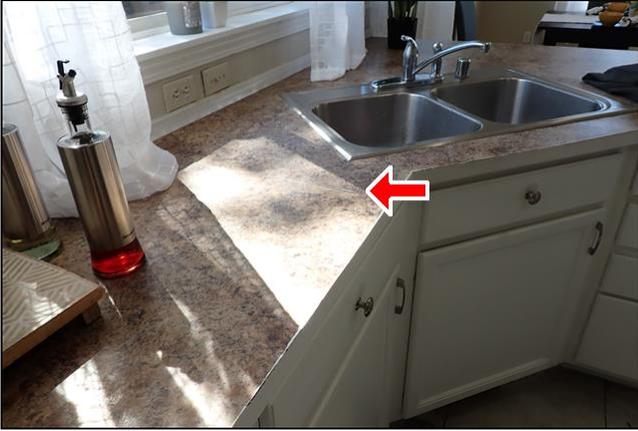
4.4 Item 1(Picture)

**4.4 FORMICA COUNTER TOP IS LOOSE AT SEAM. FURTHER EVALUATE.**

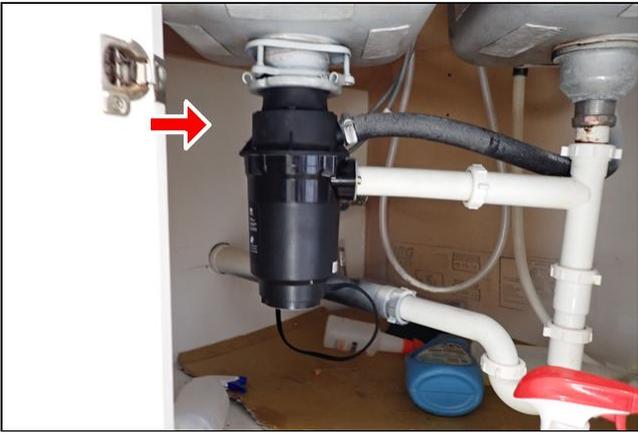
4.11 Item 1(Picture)

**4.11** The food disposer (disposal) has an object inside. I recommend repair as needed.

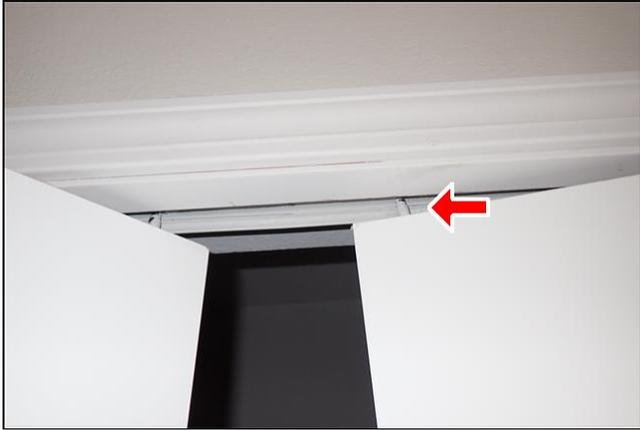
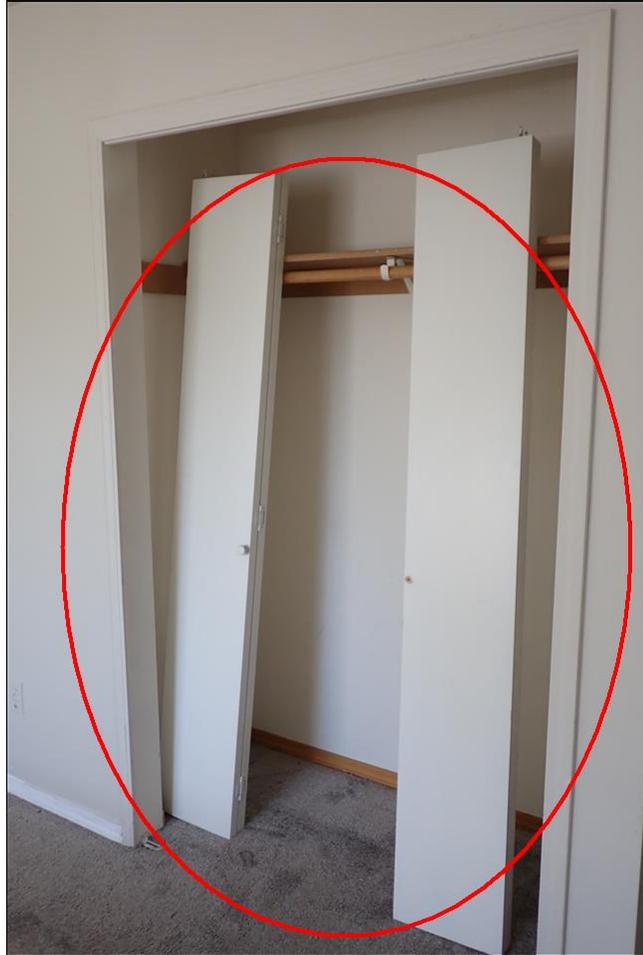
5.3 Item 1(Picture)

🏠 5.3 2 OF THE BEDROOM BIFOLD DOORS ARE OFF TRACK AND OR ARE MISSING HARDWARE. RECOMMEND FURTHER EVALUATION/REPAIR/REPLACE.

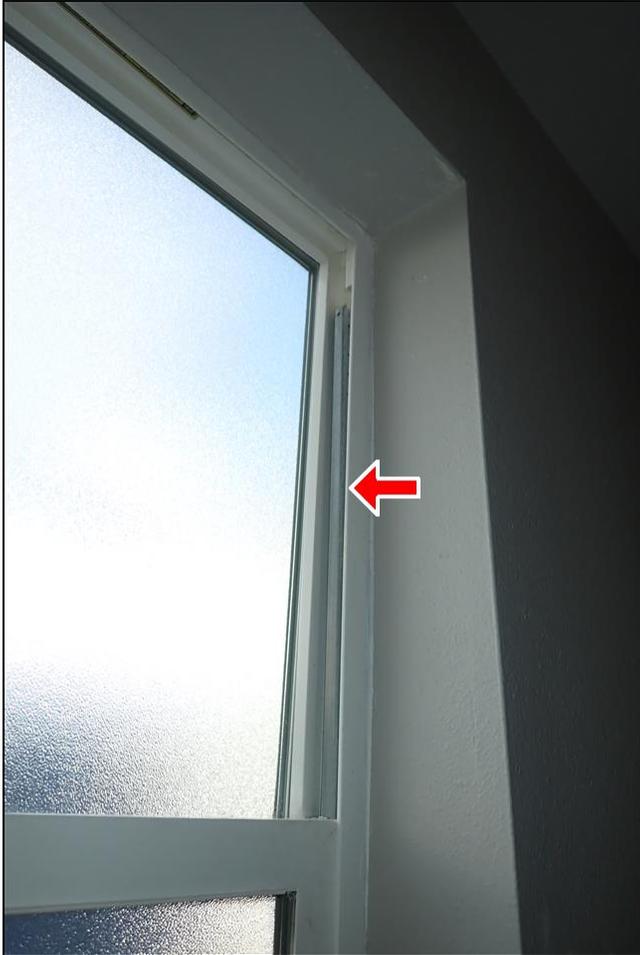
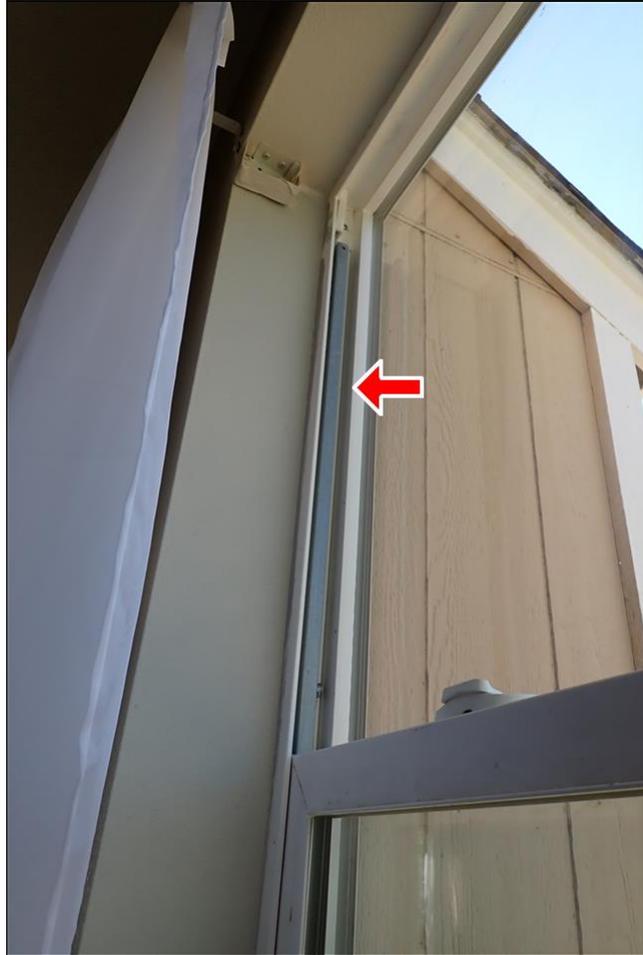
5.5 Item 1(Picture)

🏠 5.5 (1) MANY OF THE DOUBLE HUNG WINDOWS HAVE DEFECTIVE SPRING MECHANISM. RECOMMEND FURTHER EVALUATE ALL THE WINDOWS AND REPAIR WHERE NEEDED.

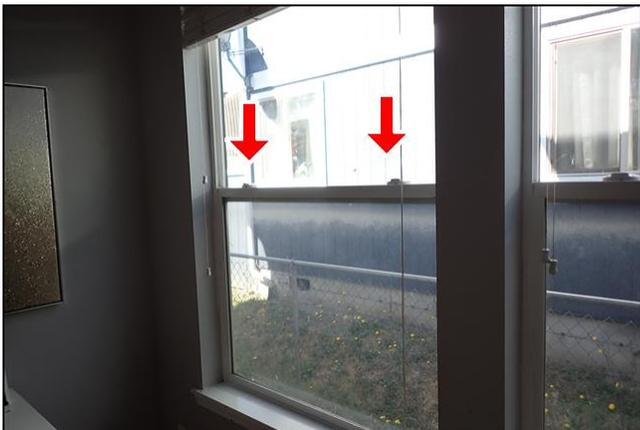
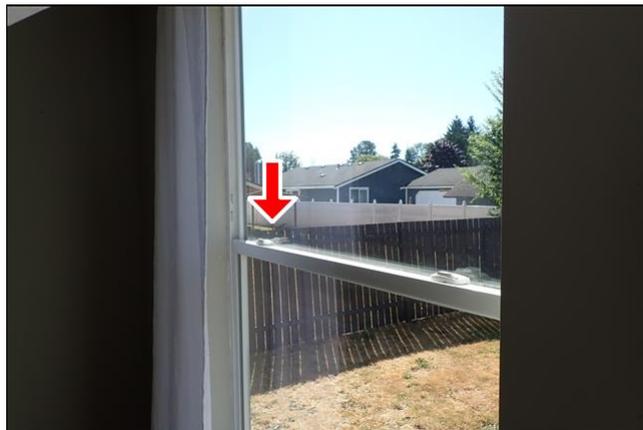
5.5 Item 3(Picture)

🏠 (2) SOME WINDOW LOCKS ARE DEFECTIVE AT VARIOUS ROOMS. RECOMMEND FURTHER EVALUATION/ REPAIR WHERE NEEDED.

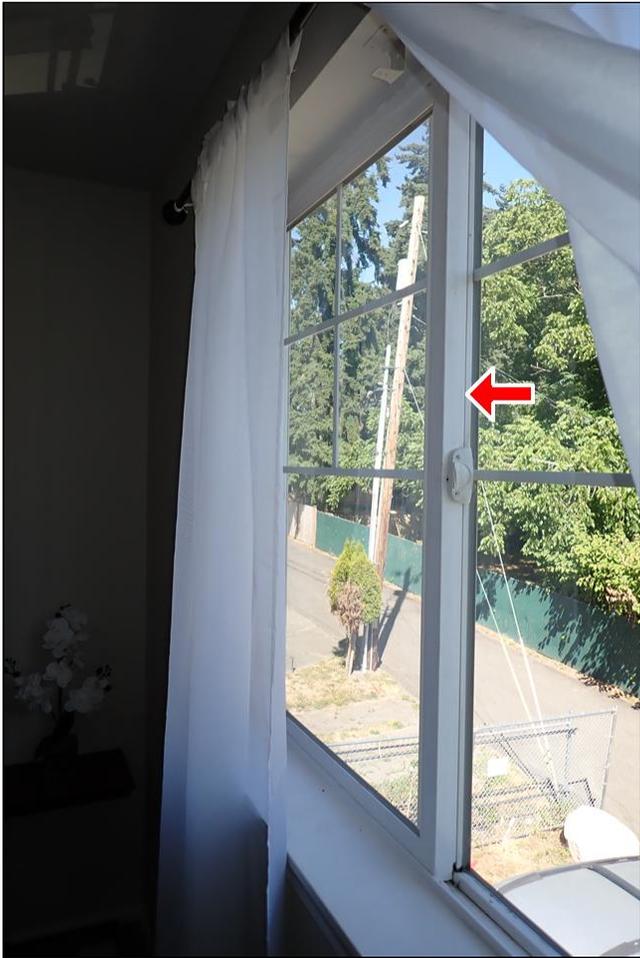
5.5 Item 5(Picture)

🏠 (3) WINDOW IN BEDROOM STUCK CLOSED. RECOMMEND FURTHER EVALUATION.

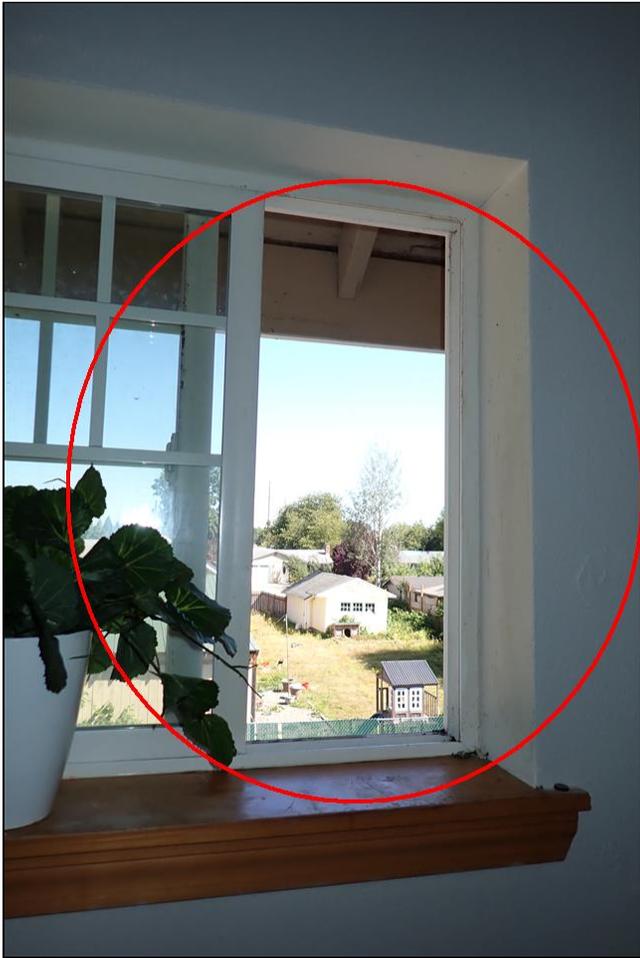
5.5 Item 6(Picture)

🏠 (4) MISSING SCREEN AT THE LAUNDRY ROOM WINDOW.

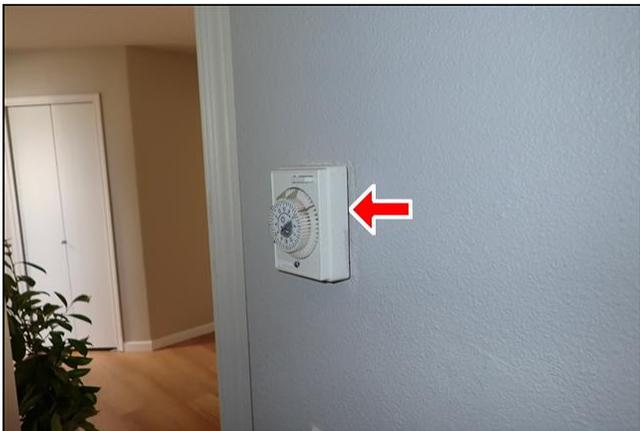
5.6 Item 1(Picture)

5.6 (1) TIMER FOR LAUNDRY FAN IS NOT CONNECTED. RECOMMEND FURTHER EVALUATION.

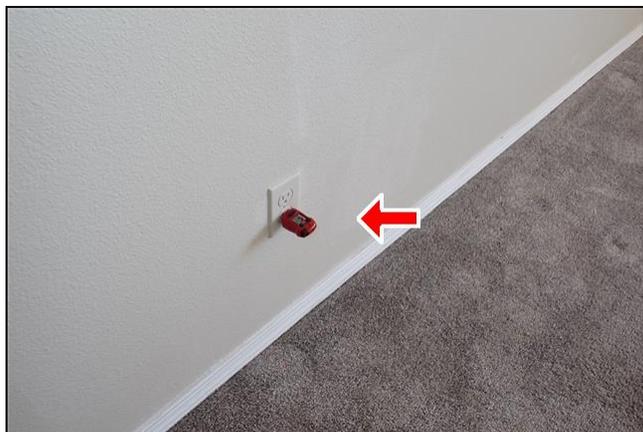
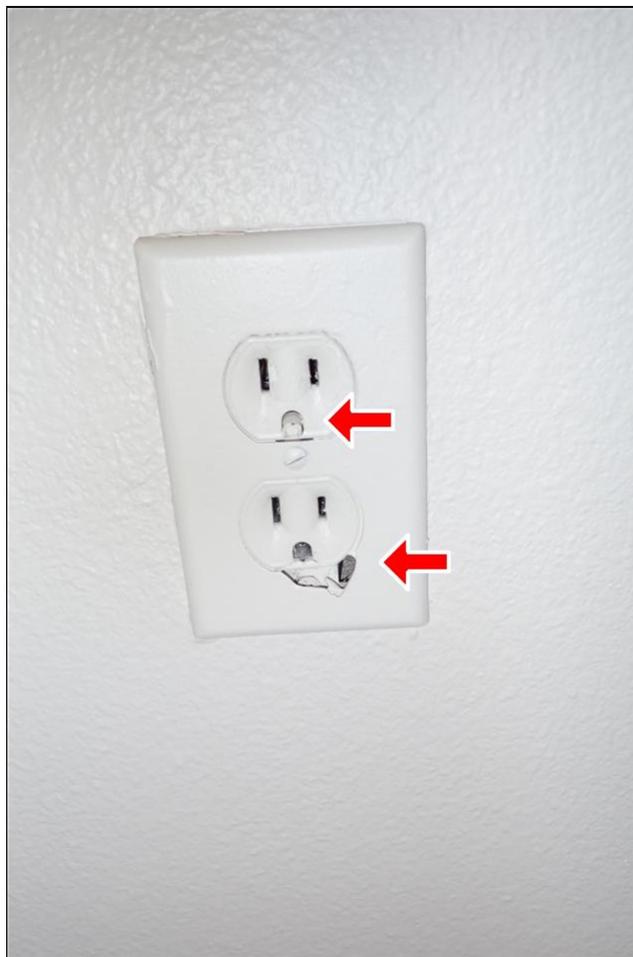
5.6 Item 2(Picture)

(2) OUTLETS NOT WORKING IN THE SOUTHWEST BEDROOM. NOTED THAT ONE OF THE OUTLETS IS DAMAGED AND HAS GROUND PRONG BROKEN OFF IN IT. RECOMMEND FURTHER EVALUATION/REPAIR BY ELECTRICIAN.

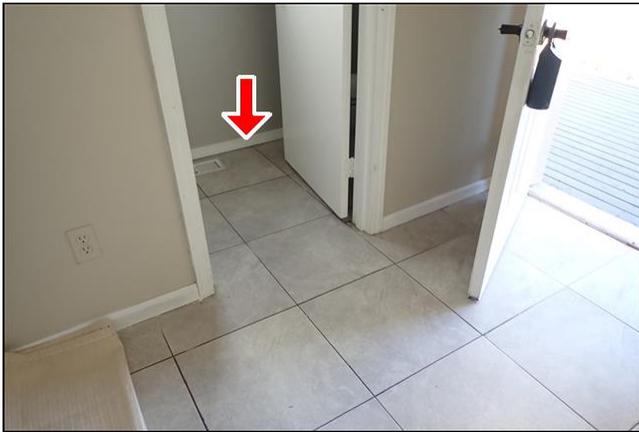
6.2.A Item 1(Picture)

**6.2.A** NOTED SOME MINOR DEFLECTION IN THE FLOOR AT THE HALF BATH. REASON IS NOT DETERMINED. FURTHER EVALUATE.

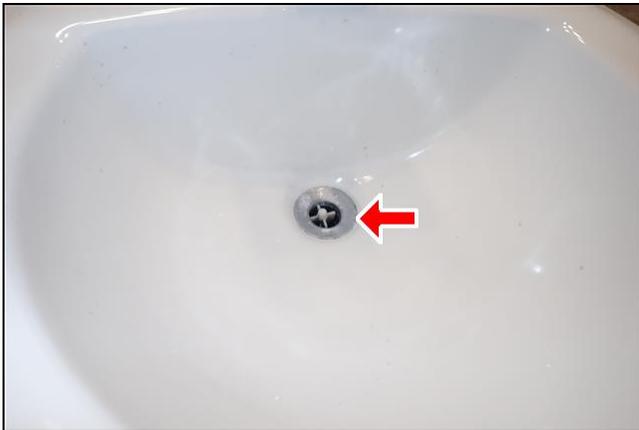
6.6.A Item 1(Picture)

**6.6.A** The stop-valve piece is MISSING. REPLACEMENT STOPPERS ARE AVAILABLE AT THE BOX STORES.

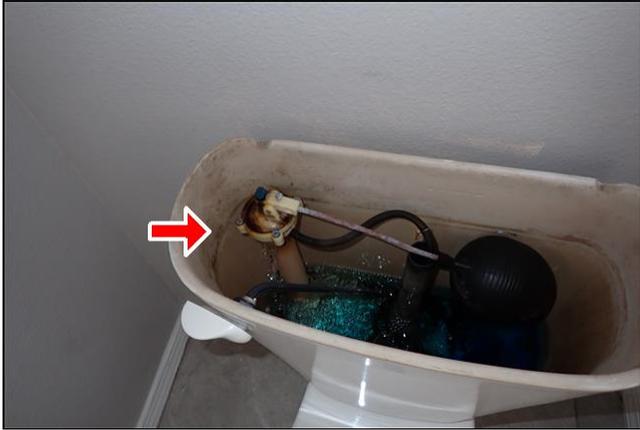
6.7.A Item 1(Picture)

**6.7.A** (1) The toilet FILLER VALVE IS OLD AND LEAKING AT DIAPHRAGM. THIS COULD CAUSE WATER TO SPRAY OUT OF THE TANK AND CAUSE DAMAGE TO FLOOR OR WALL. RECOMMEND REPLACING BEFORE MOVING IN.

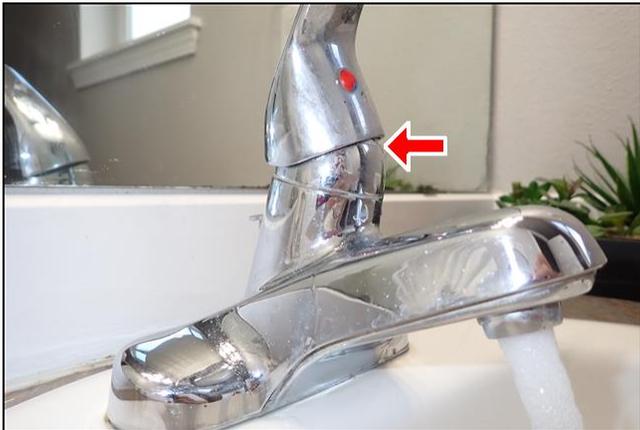
6.7.A Item 2(Picture)

**6.7.A** (2) FAUCET LEAKS AT BASE (CARTRIDGE) WHEN IN USE. RECOMMEND FURTHER EVALUATION. MAY BE BECAUSE IT'S BEEN A WHILE SINCE THE SINK WAS USED.

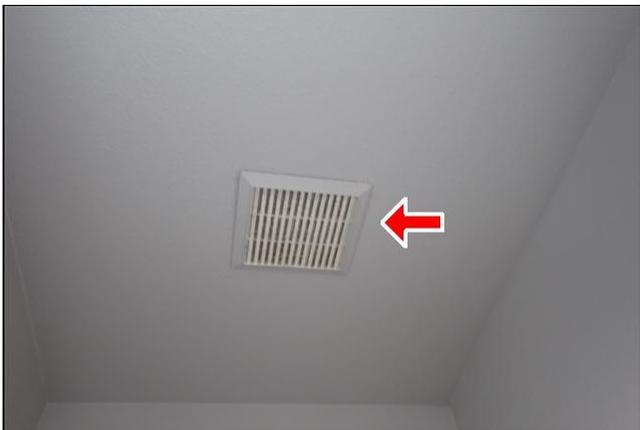
6.9.A Item 1(Picture)

**6.9.A** EXHAUST FAN IS DIRTY. THIS CAUSES RESTRICTED AIR FLOW AND IS A STRESSFUL ON THE MOTOR. RECOMMEND CLEANING AND MAINTAINING.

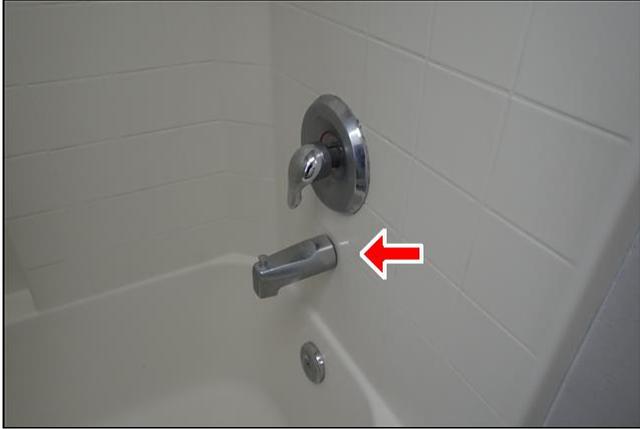
6.7.B Item 1(Picture)

**6.7.B (1)** The TUB FAUCET VALVE AND SPOUT ARE loose at the hall bath. Repairs are needed TO PREVENT WATER PENETRATION AND DAMAGE. HAVE A LICENSED PLUMBER CORRECT/REPAIR AS NEEDED.

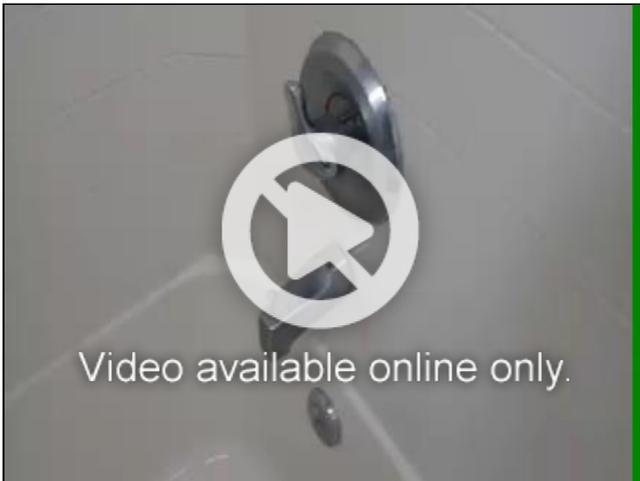
6.7.B Item 2(Video)

**6.7.B (2)** SHOWER VALVE CARTRIDGE IS MAKING INTERMITTENT NOISE. RECOMMEND FURTHER EVALUATION/REPAIR.

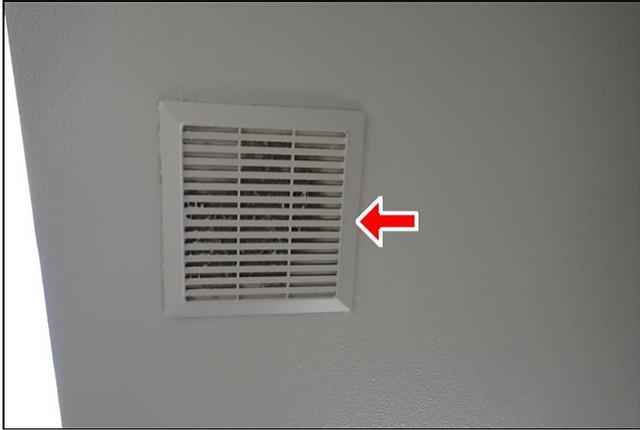
6.9.B Item 1(Picture)

**6.9.B** EXHAUST FAN IS DIRTY. THIS CAUSES RESTRICTED AIR FLOW AND IS A STRESSFUL ON THE MOTOR. RECOMMEND CLEANING AND MAINTAINING.

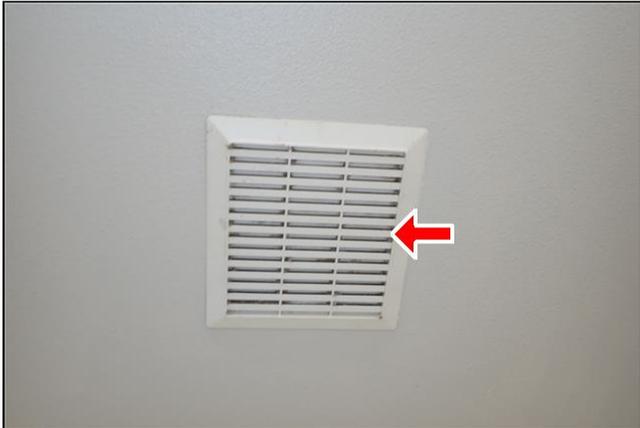
6.9.C Item 1(Picture)

**6.9.C** EXHAUST FAN IS DIRTY. THIS CAUSES RESTRICTED AIR FLOW AND IS A STRESSFUL ON THE MOTOR. RECOMMEND CLEANING AND MAINTAINING.

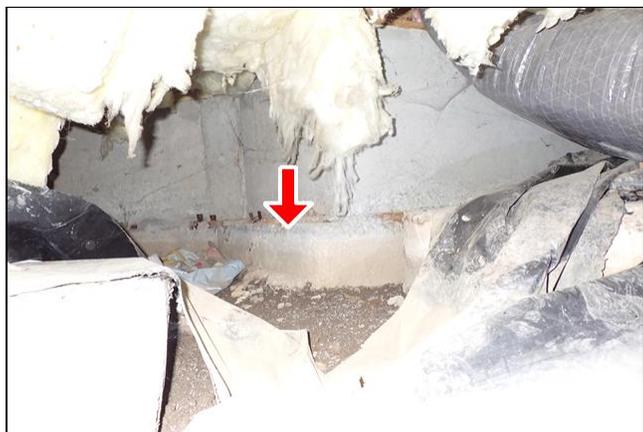
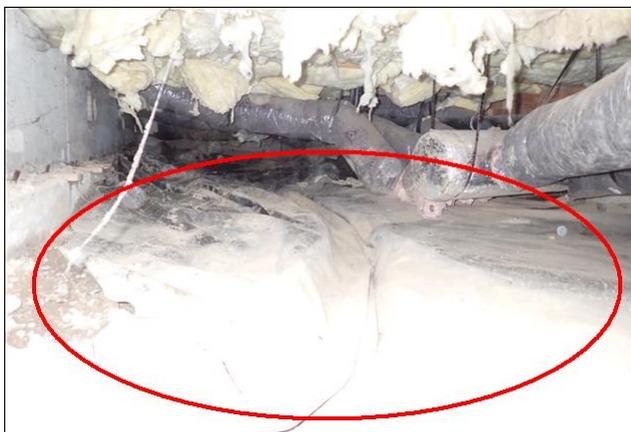
7.0 Item 1(Picture)

**7.0** (1) INDICATION WATER INTRUSION NOTED IN CRAWLSPACE WITH SILT AND STAINS ON FOUNDATION AND VAPOR BARRIER. RECOMMEND FURTHER EVALUATING/CORRECTING THE DOWNSPOUTS OR IN GROUND DRAIN SYSTEM AT THE EXTERIOR. ALSO A SUMP PUMP MIGHT NEED TO BE INSTALLED. CONSULT QUALIFIED LICENSED CONTRACTOR. NOTED THAT THE CRAWLSPACE IS IN DRY CONDITION AT THE TIME OF THE INSPECTION.

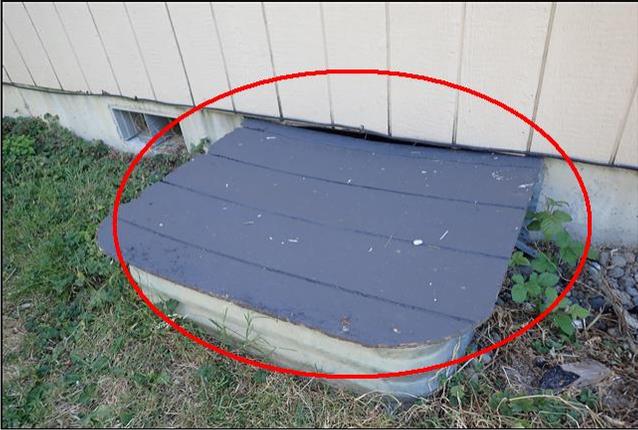
7.0 Item 3(Picture)

(2) CRAWLSPACE COVER IS WEATHERED AND DAMAGED. RECOMMEND REPLACEMENT OF THE EXISTING COVER WITH A SLOPED COVER OF WOOD OR METAL CONSTRUCTION WITH A WATER TIGHT SURFACE.

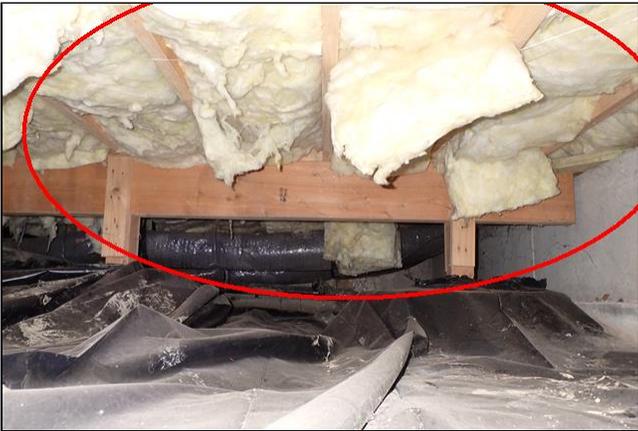
7.5 Item 1(Picture)

**7.5** The insulation is loose/fallen in the crawspace. HAVE RE-INSTALLED AS NEEDED.

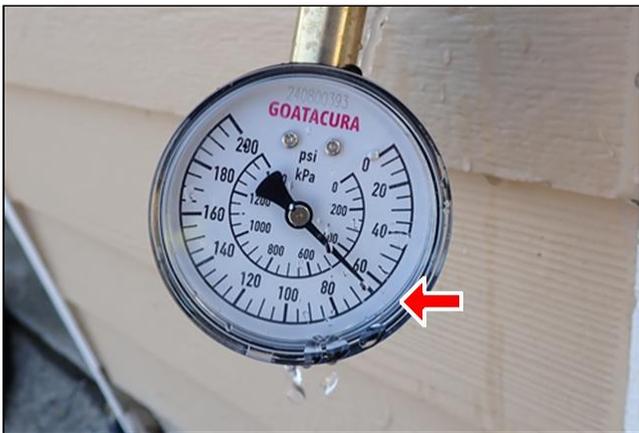
8.2 Item 1(Picture)

**8.2** THE WATER PRESSURE WAS 65 PSI TODAY. THIS IS ADEQUATE WITHIN NORMAL RANGE OF 40-80LBS.

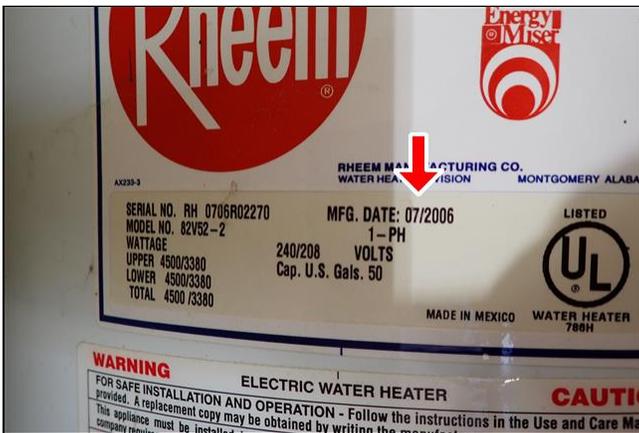
8.3 Item 1(Picture)

**8.3** WATER HEATER IS AT/BEYOND LIFE DESIGN (ORIGINAL TO HOME) YET SEEMS TO BE WORKING. I DO NOT KNOW HOW LONG UNIT WILL LAST IN FUTURE. RECOMMEND MONITORING AND BUDGET FOR FUTURE REPLACEMENT.

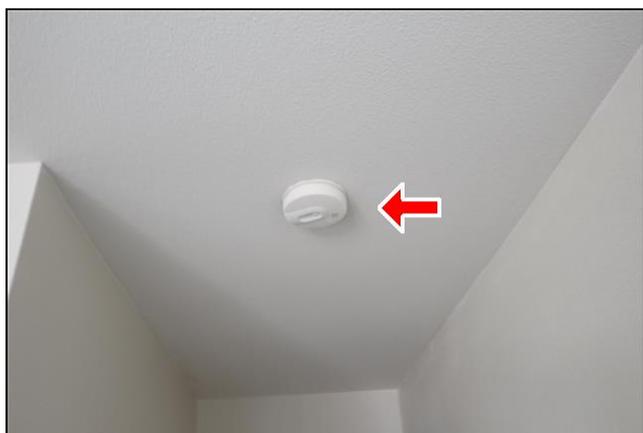
9.7 Item 1(Picture)

**9.7** THE LOCATION OF A MODERN SMOKE DETECTOR AND CARBON MONOXIDE DETECTOR SHOULD BE PLACED AS PER **INSTRUCTIONS PROVIDED** WITH UNIT AND MEET LOCAL ORDINANCE. OLDER UNITS AND BATTERIES SHOULD BE REPLACED WHEN MOVING INTO THE HOME.

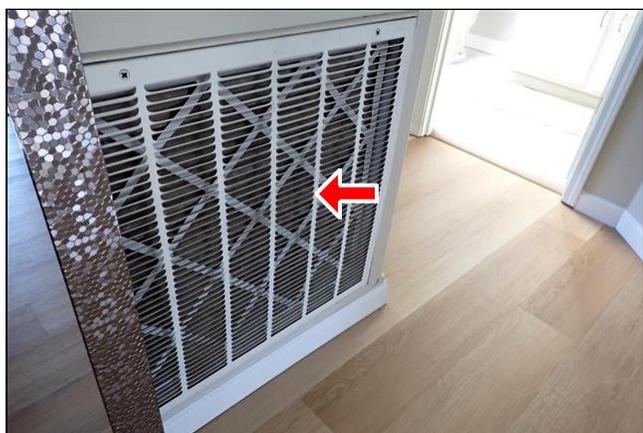
10.5 Item 1(Picture)

**10.5 (1)** The FURNACE Filter is dirty and needs CLEANING/replacing. THIS COULD CAUSE SLOWED AIR FLOW AND CAN BE HARD ON THE SYSTEM. RECOMMEND CLEANING/CHANGING FILTER AT SEASON CHANGES (THREE MONTH INTERVALS).

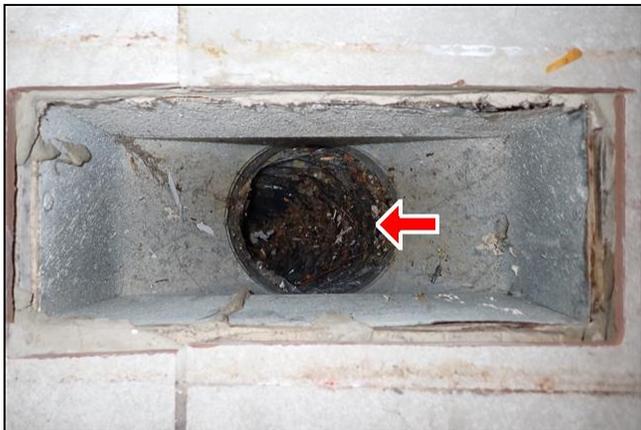
10.5 Item 2(Picture)

(2) The debris seen in the vents AND DUST BUILD AT COLD RETURN indicates the need for cleaning ducts with a PROFESSIONAL vacuum SERVICE.

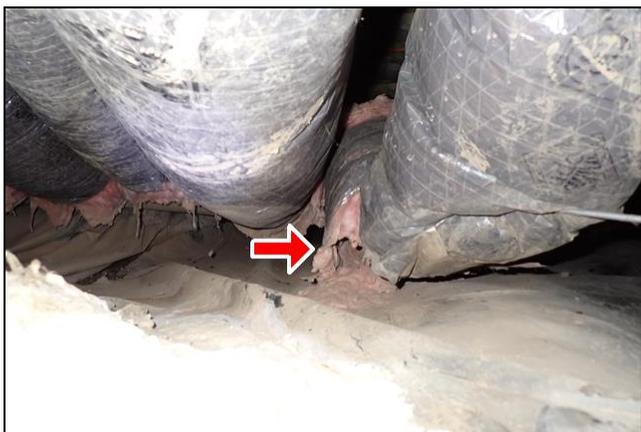
10.5 Item 3(Picture)

(3) HOLE IN HEAT DUCT IN THE CRAWLSPACE FROM WATER DAMAGE. HOW MANY HOLES THAT MAY BE PRESENT IS NOT KNOWN. RECOMMEND FURTHER EVALUATION/REPAIR OR REPLACE.

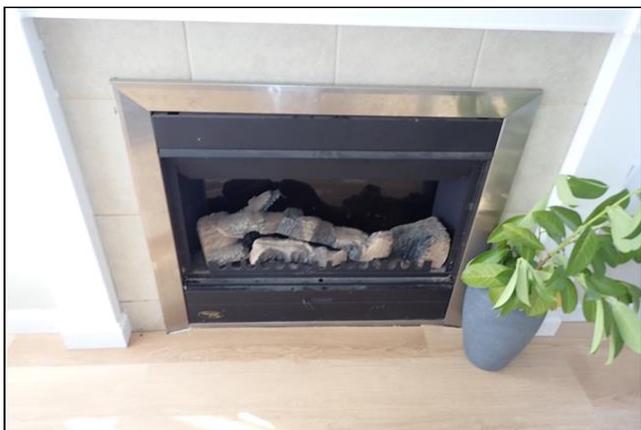
10.7 Item 1(Picture)

10.7 FIREPLACE IS DECORATIVE ELECTRIC.
